NASA/CR-2017-219668

# Hybrid Wing Body Multi-Bay Test Article Analysis and Assembly Final Report

*Alexander Velicki, Krishna Hoffman, Kim A. Linton, Jaime Baraja,  
Hsi-Yung T. Wu and Patrick Thrash  
The Boeing Company, Huntington Beach, California*

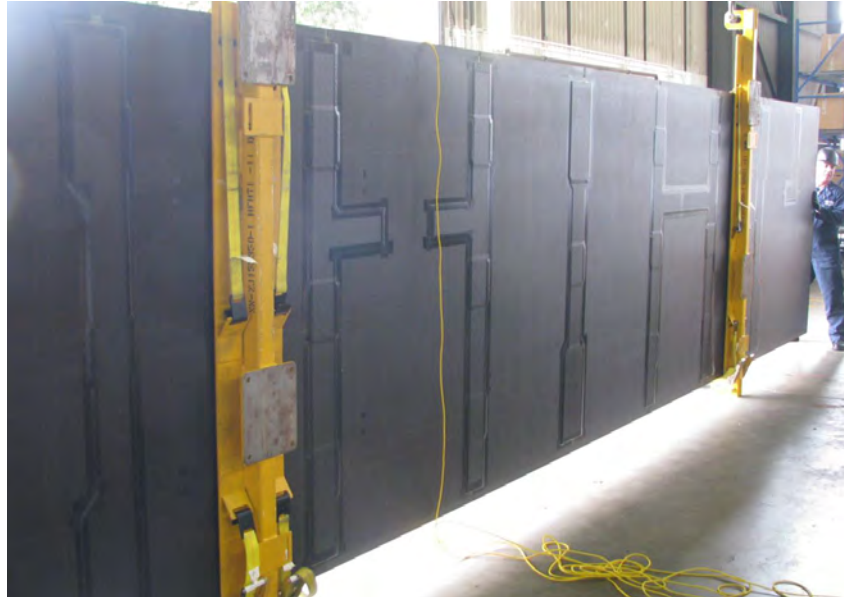
Due to the large variation in geometric complexity of the internal structure covered by the patches, the use of common inspection techniques using pre-sampled reference standards was not practical; therefore, no ultrasonic nondestructive inspection was performed. The repair was approved based on using the same process-control standards as used for the test coupons (visual inspection of the adhesive wet-out and tap testing of the completed repair), which, ultimately, replicated the favorable results of the coupon test effort. The repaired panel was then delivered to the assembly site (Figure B-15).

**Figure B-15. Completed Bonded Repair Patches on Crown Panel OML**
